**Flood Control Project Maintenance  
Levee Inspections**

## Maintenance Issue Types Only, Levee Inspection Report By Mile - Spring 2018

### Reclamation District No. 1001 Nicolaus

Waterway	Bank	Unit Miles	Inspection Start/End	Inspector
Unit No. 01 Yankee Slough	Right	4.12	04/03/2018 04/03/2018	Sterling York

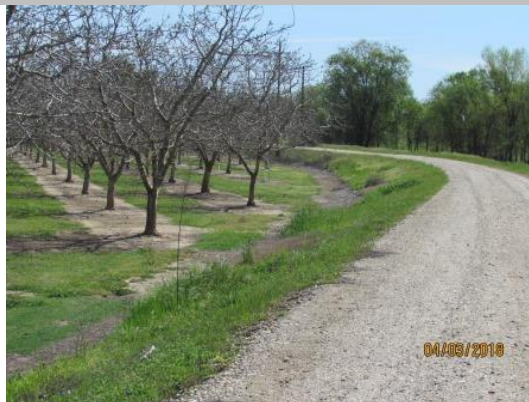
Photo 1 of 2 : SP\_2018\_RD1001\_36\_11\_20180411\_00022.jpg

LM Start	0.02	Rating **	A	Issue No.	11
LM End	3.83	Issue Type +	Ma	Location *	LS
Category	Earthen Levee			GPS Latitude/Longitude	
				Start	End
Item	Vegetation			38.980099 °	38.966746 °
				-121.470405 °	-121.533402 °
DWR ID	DWR_RD1001_01_s_2018_11				
Comment Code					
V1 : Control annual grass and weeds on the levee slopes and easements.					
Inspector Comment					
Annual vegetation is well maintained, Spring 2018.

View looking upstream landside of the well maintained annual vegetation, Spring 2018.

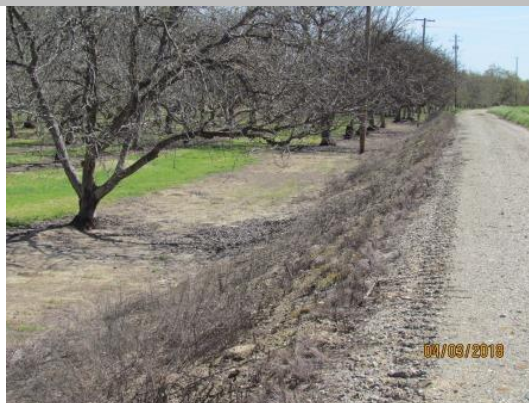
Photo 2 of 2 : SP\_2018\_RD1001\_36\_11\_20180411\_00021.jpg

Second view looking upstream landside of the well maintained annual vegetation, Spring 2018.

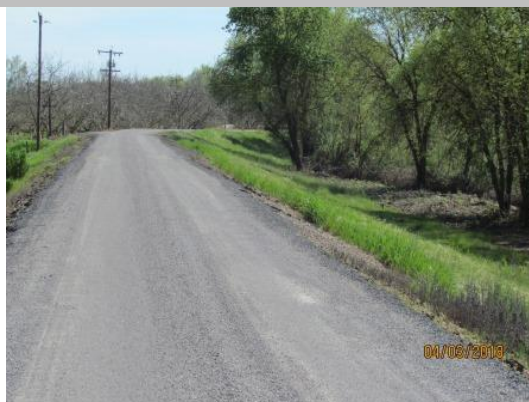
Photo 1 of 1 : SP\_2018\_RD1001\_36\_12\_20180411\_00024.jpg

LM Start	0.02	Rating **	A	Issue No.	12
LM End	3.83	Issue Type +	Ma	Location *	WS
Category	Earthen Levee			GPS Latitude/Longitude	
				Start	End
Item	Vegetation			38.980099 °	38.966746 °
				-121.470405 °	-121.533403 °
DWR ID	DWR_RD1001_01_s_2018_12				
Comment Code					
V1 : Control annual grass and weeds on the levee slopes and easements.					
Inspector Comment					
Annual vegetation is well maintained, Spring 2018.

View looking upstream waterside of the well maintained annual vegetation, Spring 2018.

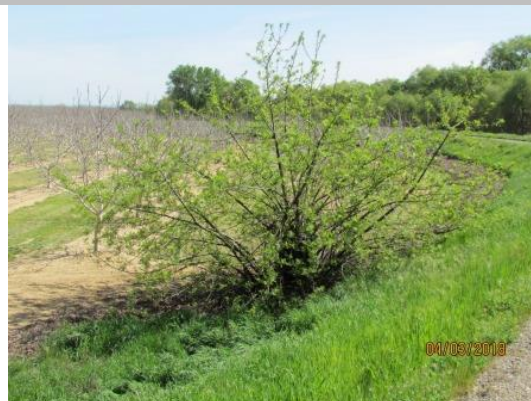
Photo 1 of 2 : SP\_2018\_RD1001\_36\_19\_20180411\_00026.jpg

View of a tree that need limbs trimmed, Spring 2018.

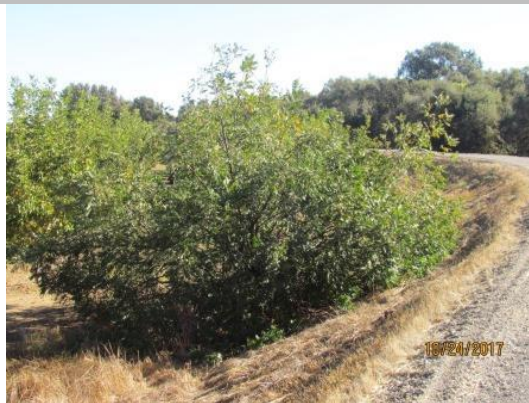
Photo 2 of 2 : SP\_2018\_RD1001\_36\_19\_20180302\_00014.jpg

View of a tree that need limbs trimmed. Fall 2017.

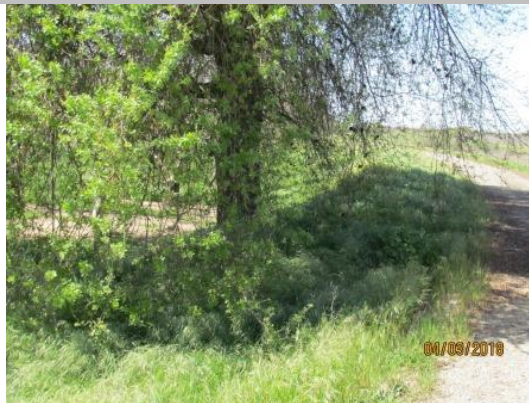
Photo 1 of 1 : SP\_2018\_RD1001\_35\_14\_20180411\_00030.jpg

View looking downstream landside of tree that needs its limbs trimmed for access and visibility, Spring 2018.

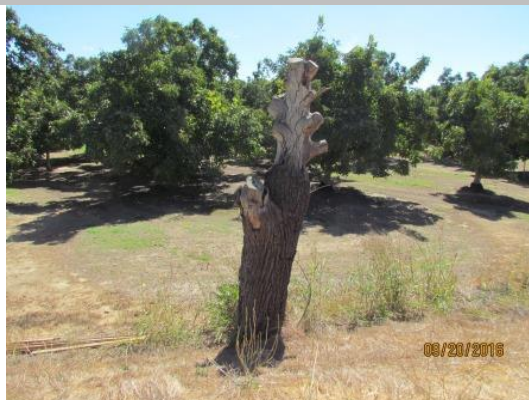
Photo 1 of 1 : SP\_2018\_RD1001\_35\_13\_20180302\_00009.jpg

View of large stump at the landside levee toe. Fall 2016.

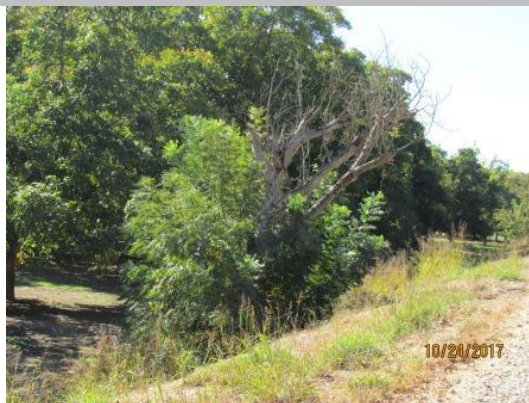
Photo 1 of 1 : SP\_2018\_RD1001\_35\_5\_20180302\_00001.jpg

View looking downstream landside at a large stump that needs to be removed, Fall 2017.

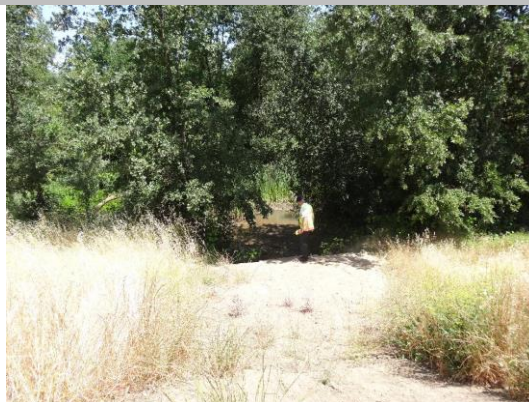
Photo 1 of 3 : UCIP\_SP\_2018\_14008\_23108.jpg

LM Start	2.28	Rating **	M	Issue No.	55
LM End	2.28	Issue Type +	Ma	Location *	
Category	Supplemental			GPS Latitude/Longitude	
				Start	End
Item	DWR UCIP LMA Responsibility			38.967403 °	38.967403 °
				-121.510953 °	-121.510953 °
DWR ID					
Comment Code					
Inspector Comment					
FS_ID:14008 DS_ID:22543 EP_NO: N/A Repair Type: Non-Urgent Crossing Status: Found UCIP Comments: - slide gate in inlet pipe on landside - pits on pipe due to corrosion FIELD_STRUCT_DESC: 36-inch corrugated metal gravity drainage pipe through the levee, 15 feet below the crown. Flap gate and concrete U-shaped headwall at outfall on the waterside (WS) end. Slide gate at inlet on the landside (LS) end. (Reclamation District No. 1001). [Additional Reference(s): DWR Levee Log, 1993. USACE Sacramento O&M Manual 141.1, August 1955, (Station 67+75)]. FS Date: 5/23/2013

WS- overview of waterside of the levee.

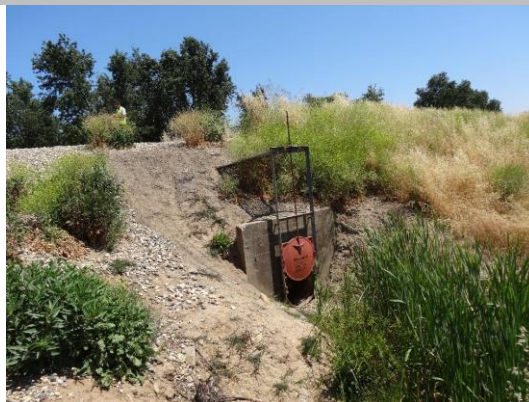
Photo 3 of 3 : UCIP\_SP\_2018\_14008\_23106.jpg

LM Start	2.28	Rating **	M	Issue No.	55 (cont)	
LM End	2.28	Issue Type +	Ma	Location *		
Category	Supplemental			GPS Latitude/Longitude		
				Start	End	
Item	DWR UCIP LMA Responsibility			38.967403 °	38.967403 °	
				-121.510953 °	-121.510953 °	
DWR ID						
Comment Code						
Inspector Comment						
FS_ID:14008 DS_ID:22543 EP_NO: N/A Repair Type: Non-Urgent Crossing Status: Found UCIP Comments: - slide gate in inlet pipe on landside - pits on pipe due to corrosion FIELD_STRUCT_DESC: 36-inch corrugated metal gravity drainage pipe through the levee, 15 feet below the crown. Flap gate and concrete U-shaped headwall at outfall on the waterside (WS) end. Slide gate at inlet on the landside (LS) end. (Reclamation District No. 1001). [Additional Reference(s): DWR Levee Log, 1993. USACE Sacramento O&M Manual 141.1, August 1955, (Station 67+75)]. FS Date: 5/23/2013

LS- slide gate in inlet pipe structure

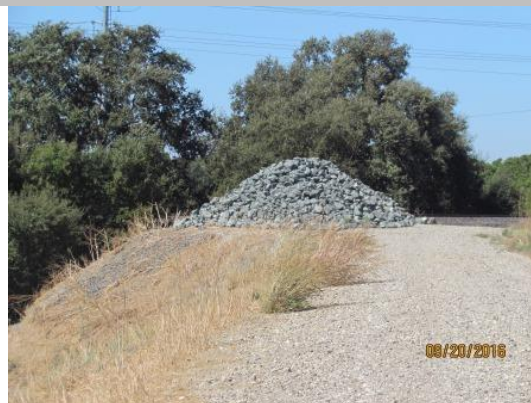
Photo 1 of 1 : SP\_2018\_RD1001\_35\_24\_20180302\_00016.jpg

View of stockpiled flood fight material. Fall 2016.

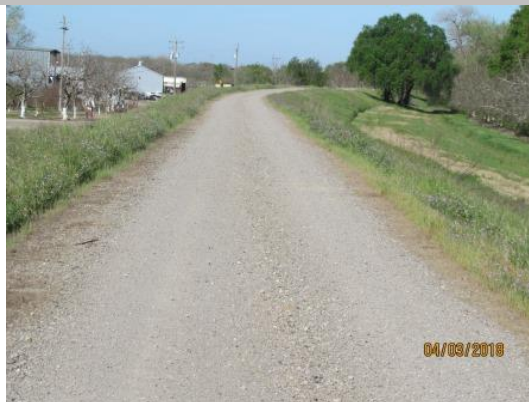
Photo 1 of 1 : SP\_2018\_RD1001\_37\_15\_20180409\_00052.jpg

View looking downstream waterside of the well maintained annual vegetation, Spring 2018.

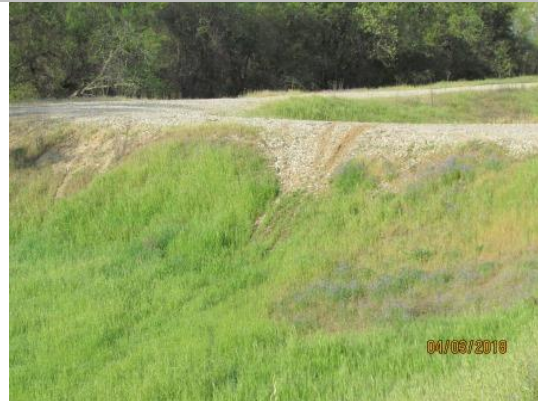
Photo 1 of 1 : SP\_2018\_RD1001\_37\_2\_20180409\_00055.jpg

LM Start	0.11	Rating **	M	Issue No.	2
LM End	0.11	Issue Type +	Ma	Location *	CR
Category	Earthen Levee			GPS Latitude/Longitude	
				Start	End
Item	Slope Stability			39.006569 °	39.006569 °
				-121.377037 °	-121.377037 °
DWR ID	DWR_RD1001_03_f _ 2013_2				
Comment Code					
S3 : Repair the levee slope damaged by vehicle traffic and prevent access where possible.					
Inspector Comment					
Rutting caused by vehicles driving up the landward levee slope, Spring 2018.

View of rutting on the landside levee facing downstream. Spring 2018.

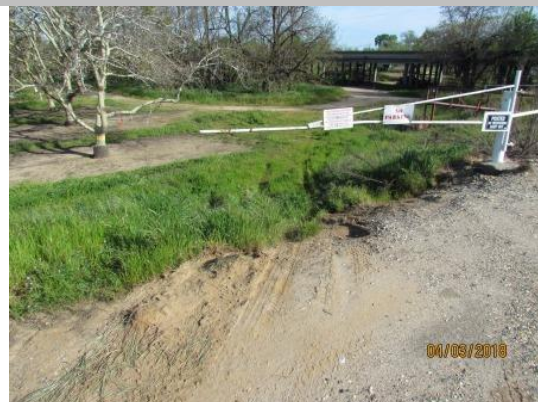
Photo 1 of 2 : SP\_2018\_RD1001\_37\_28\_20180409\_00057.jpg

LM Start	1.87	Rating **	M	Issue No.	28
LM End	1.87	Issue Type +	Ma	Location *	WS
Category	Earthen Levee			GPS Latitude/Longitude	
				Start	End
Item	Slope Stability			38.998608 °	38.998608 °
				-121.405570 °	-121.405570 °
DWR ID	DWR_RD1001_03_s_2013_28				
Comment Code					
S3 : Repair the levee slope damaged by vehicle traffic and prevent access where possible.					
Inspector Comment					
Continual damage to waterside slope caused by vehicles, suggest blocking access.

Continual damage to waterside slope caused by vehicles. Spring 2018.

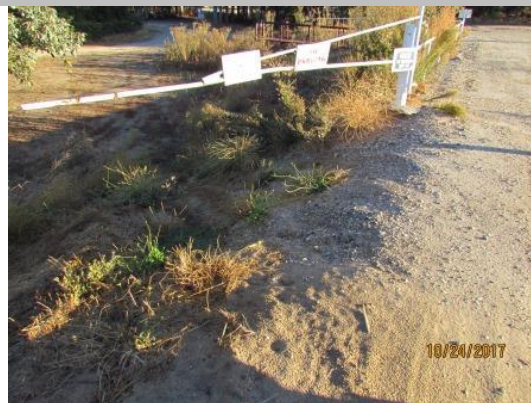
Photo 2 of 2 : SP\_2018\_RD1001\_37\_28\_20180302\_00022.jpg

LM Start	1.87	Rating **	M	Issue No.	28 (cont)	
LM End	1.87	Issue Type +	Ma	Location *	WS	
Category	Earthen Levee			GPS Latitude/Longitude		
				Start		End
Item	Slope Stability			38.998608 °		38.998608 °
				-121.405570 °		-121.405570 °
DWR ID	DWR_RD1001_03_s_2013_28					
Comment Code						
S3 : Repair the levee slope damaged by vehicle traffic and prevent access where possible.						
Inspector Comment						
Continual damage to waterside slope caused by vehicles, suggest blocking access.

Continual damage to waterside slope caused by vehicles. Fall 2017.

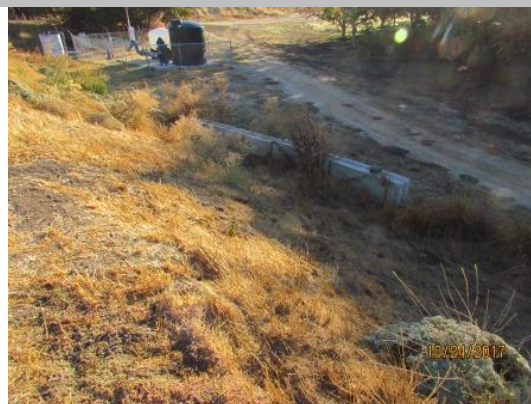
Photo 1 of 1 : SP\_2018\_RD1001\_37\_29\_20180302\_00023.jpg

LM Start	1.87	Rating **	A/W	Issue No.	29
LM End	1.87	Issue Type +	Ma	Location *	LS
Category	Earthen Levee			GPS Latitude/Longitude	
				Start	End
Item	Slope Stability			38.998608 °	38.998608 °
				-121.405570 °	-121.405570 °
DWR ID	DWR_RD1001_03_s_2013_29				
Comment Code					
S3 : Repair the levee slope damaged by vehicle traffic and prevent access where possible.					
Inspector Comment					
Continual damage caused by vehicles going around the gate, has been fixed and blocks added.

Continual damage caused by vehicles going around the gate. Fall 2017.

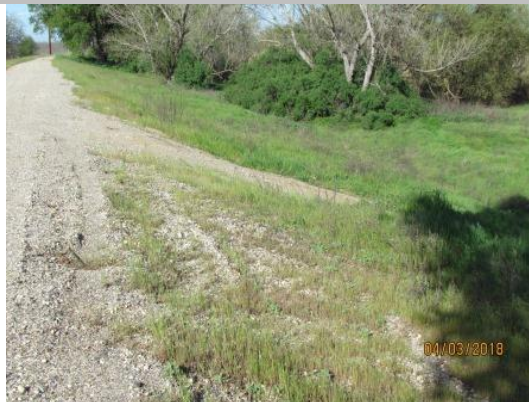
Photo 1 of 2 : SP\_2018\_RD1001\_37\_30\_20180409\_00059.jpg

LM Start	2.28	Rating **	M	Issue No.	30
LM End	2.28	Issue Type +	Ma	Location *	WS
Category	Earthen Levee			GPS Latitude/Longitude	
				Start	End
Item	Slope Stability			38.996302 °	38.996302 °
				-121.412285 °	-121.412285 °
DWR ID	DWR_RD1001_03_s_2013_30				
Comment Code					
S3 : Repair the levee slope damaged by vehicle traffic and prevent access where possible.					
Inspector Comment					
Damage to landside slope by vehicles needs to be repaired, Spring 2018.

View looking downstream waterside where slope has been disturbed by vehicle traffic, Spring 2018.

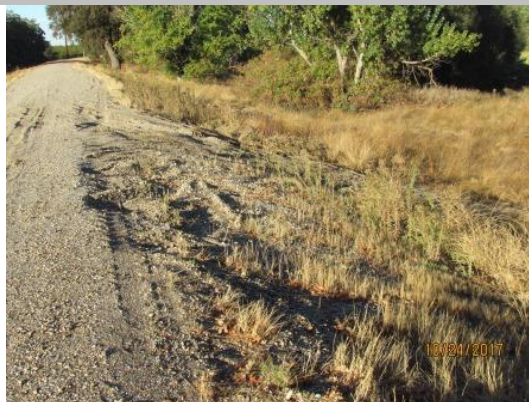
Photo 2 of 2 : SP\_2018\_RD1001\_37\_30\_20180302\_00024.jpg

View looking downstream waterside where slope has been disturbed by vehicle traffic, Fall 2017.

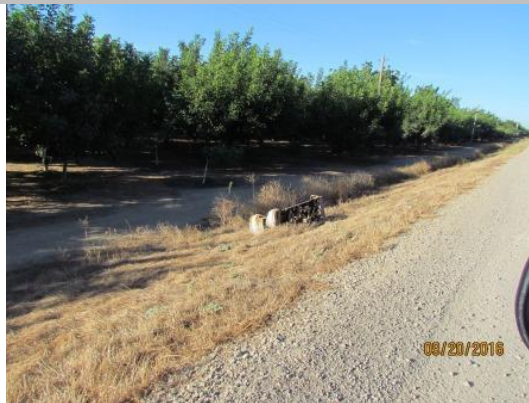
Photo 1 of 1 : SP\_2018\_RD1001\_37\_42\_20180302\_00036.jpg

View of a couch on the landside levee slope looking downstream. Fall 2016.

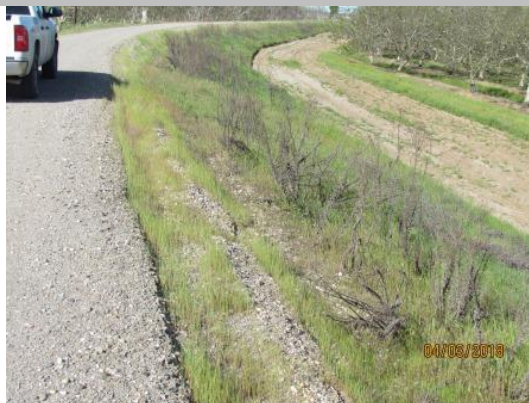
Photo 1 of 2 : SP\_2018\_RD1001\_37\_21\_20180409\_00063.jpg

LM Start	3.57	Rating **	M	Issue No.	21
LM End	3.57	Issue Type +	Ma	Location *	WS
Category	Earthen Levee			GPS Latitude/Longitude	
				Start	End
Item	Erosion / Bank Caving			38.991390 °	38.991390 °
				-121.435268 °	-121.435268 °
DWR ID	DWR_RD1001_03_s_2016_21				
Comment Code					
E2 : Schedule repair of erosion site prior to the next inspection.					
Inspector Comment

Erosion on waterside slope still remains as of Spring 2018.

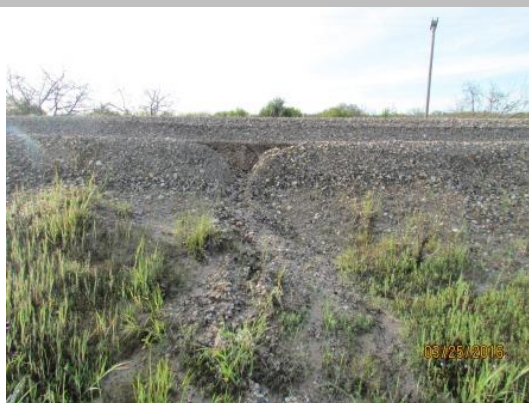
Photo 2 of 2 : SP\_2018\_RD1001\_37\_21\_20180302\_00019.jpg

Erosion on waterside slope. Remains as of Fall 2016.

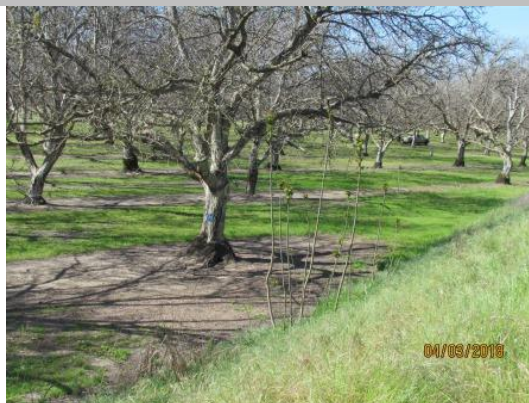
Photo 1 of 1 : SP\_2018\_RD1001\_37\_32\_20180409\_00070.jpg

View of landside were trees less than 4" in diameter should be removed, Spring 2018.

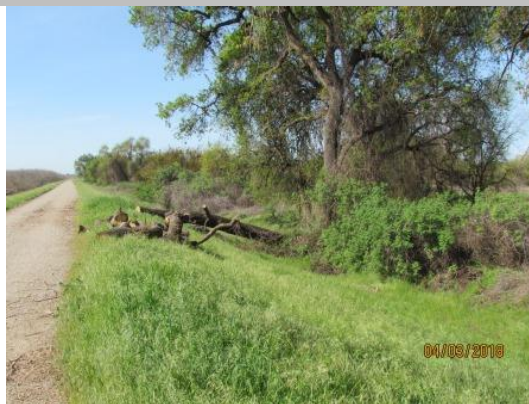
Photo 1 of 1 : SP\_2018\_RD1001\_37\_25\_20180409\_00076.jpg

View looking downstream waterside of a fallen tree that needs to be removed, Spring 2018.

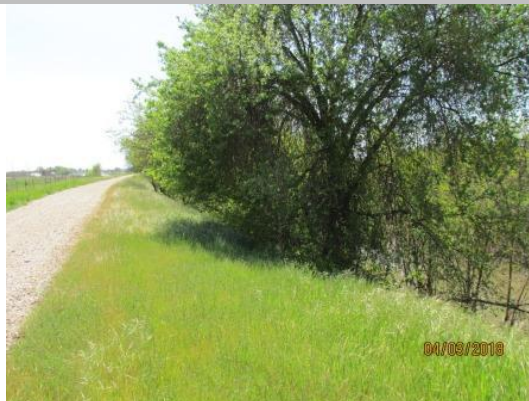
Photo 1 of 1 : SP\_2018\_RD1001\_37\_31\_20180409\_00077.jpg

View looking downstream waterside of tree that needs trimmed for access and visibility, Spring 2018.

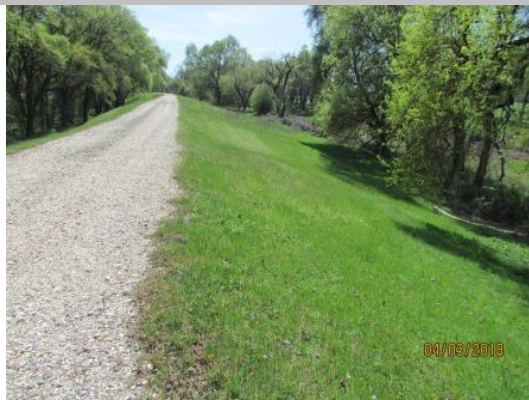
Photo 1 of 1 : SP\_2018\_RD1001\_38\_39\_20180411\_00084.jpg

View looking downstream waterside of the well maintained annual vegetation, Spring 2018.

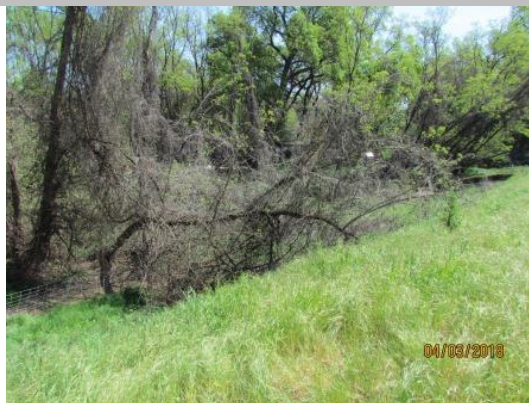
Photo 1 of 2 : SP\_2018\_RD1001\_38\_31\_20180411\_00085.jpg

View looking downstream landside of a downed tree that need to be removed from levee slope, Spring 2018.

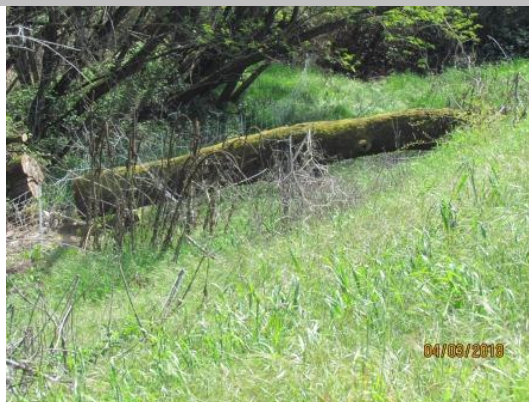
Photo 2 of 2 : SP\_2018\_RD1001\_38\_31\_20180411\_00086.jpg

Second view looking downstream landside of a downed tree that need to be removed from levee slope, Spring 2018.

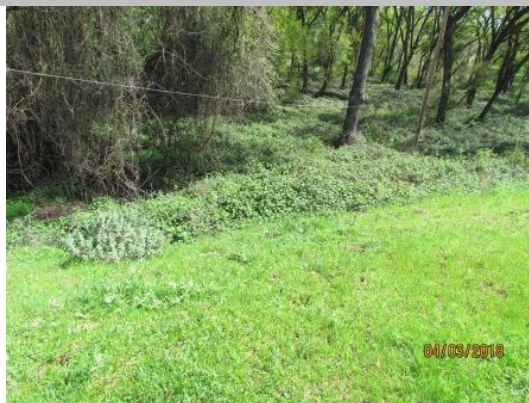
Photo 1 of 1 : SP\_2018\_RD1001\_38\_46\_20180411\_00087.jpg

View looking downstream landside of wild growth that is creeping up the levee slope, Spring 2018.

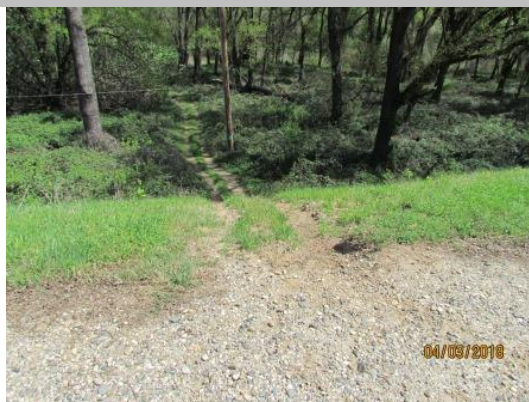
Photo 1 of 1 : SP\_2018\_RD1001\_38\_63\_20180411\_00088.jpg

View of landside slope erosion caused by vehicles, Spring 2018.

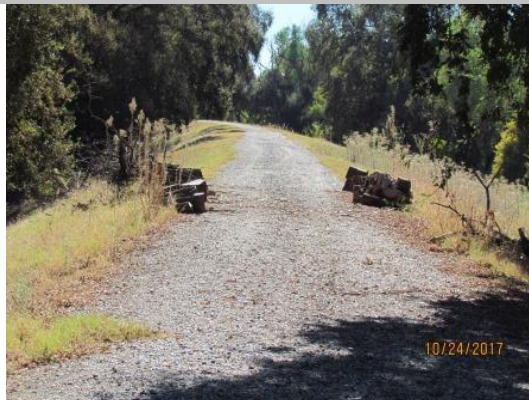
Photo 2 of 2 : SP\_2018\_RD1001\_38\_42\_20180302\_00029.jpg

View looking downstream of pruning's from fallen tree on both sides of hinge points, Fall 2017.

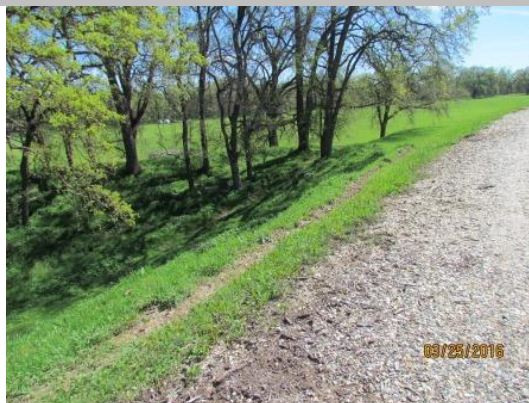
Photo 1 of 3 : SP\_2018\_RD1001\_38\_64\_20180302\_00049.jpg

Livestock trail cut into landside slope. Spring 2016.

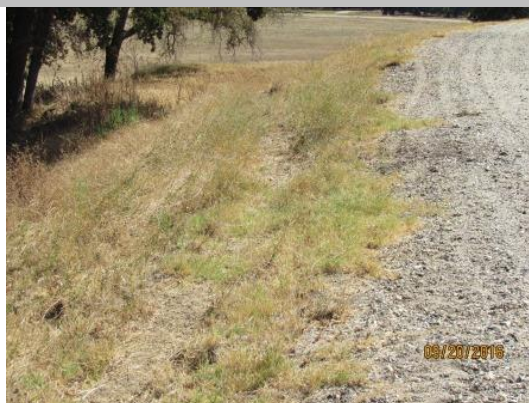
Photo 2 of 3 : SP\_2018\_RD1001\_38\_64\_20180302\_00050.jpg

View of animal trail cut into the landside levee slope. Fall 2016.

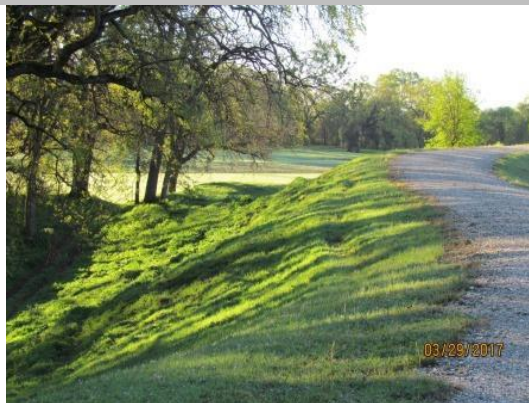
Photo 3 of 3 : SP\_2018\_RD1001\_38\_64\_20180302\_00051.jpg

View looking downstream of animal trail that is not being used and shows no sign of erosion or sloughing. Spring 2017.

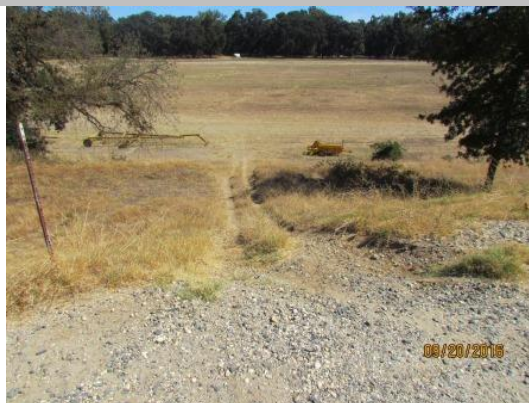
Photo 1 of 1 : SP\_2018\_RD1001\_38\_16\_20180302\_00009.jpg

View of rut made up the landside levee slope. Fall 2016.

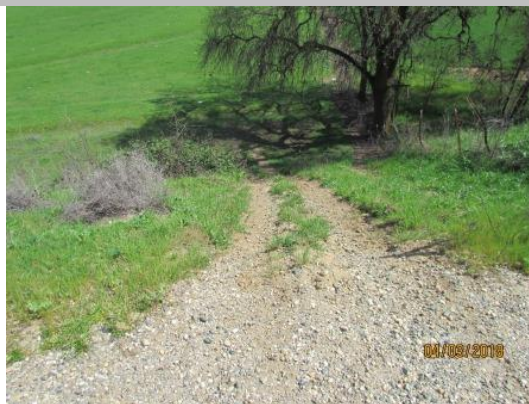
Photo 1 of 1 : SP\_2018\_RD1001\_38\_68\_20180411\_00090.jpg

View of ruts caused by vehicle on the landside levee slope. Spring 2018.

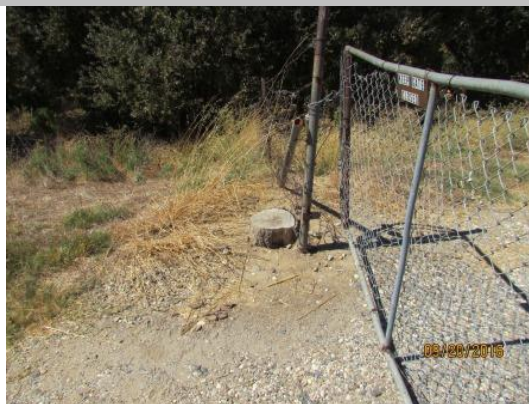
Photo 1 of 1 : SP\_2018\_RD1001\_38\_60\_20180302\_00046.jpg

View of tree stump, waterside crown at gate. Fall 2016.

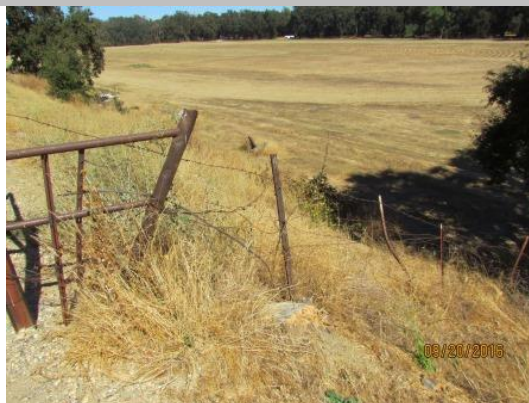
Photo 1 of 1 : SP\_2018\_RD1001\_38\_61\_20180302\_00047.jpg

View of tree stump, landside crown at gate. Fall 2016.

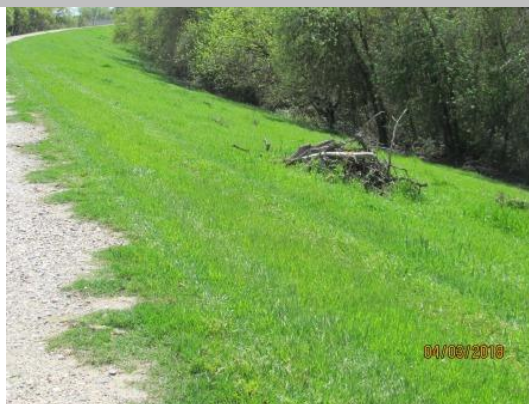
Photo 1 of 2 : SP\_2018\_RD1001\_38\_67\_20180411\_00092.jpg

LM Start	1.51	Rating **	M	Issue No.	67
LM End	1.51	Issue Type +	Ma	Location *	WS
Category	Earthen Levee			GPS Latitude/Longitude	
				Start	End
Item	Encroachments			38.919643 °	38.919643 °
				-121.569233 °	-121.569233 °
DWR ID	DWR_RD1001_04_f_2017_67				
Comment Code					
PR : Prunings					
Inspector Comment					
Remove pruning's from levee slope, Spring 2018.

View looking downstream waterside of pruning's on the levee slope, Spring 2018.

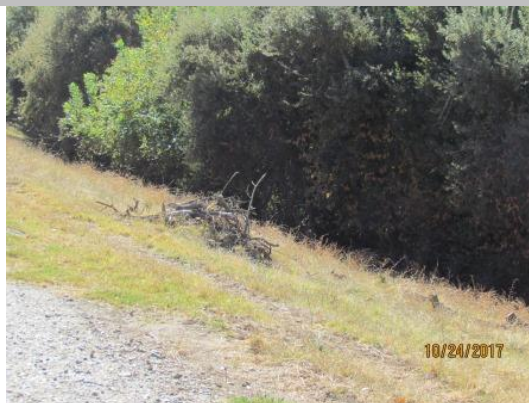
Photo 2 of 2 : SP\_2018\_RD1001\_38\_67\_20180302\_00055.jpg

View looking downstream waterside of pruning's on the levee slope, Fall 2017.

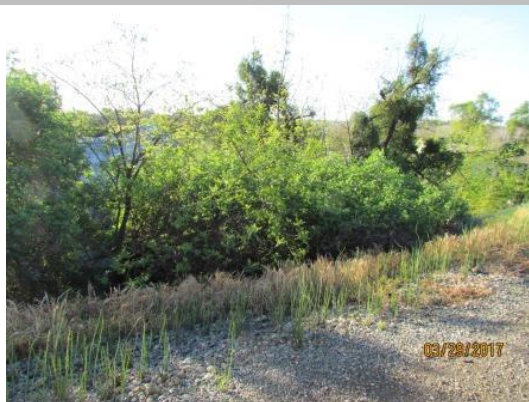
Photo 1 of 1 : SP\_2018\_RD1001\_38\_47\_20180302\_00035.jpg

View looking downstream where limbs need to be trimmed 5' for visibility, Spring 2017.

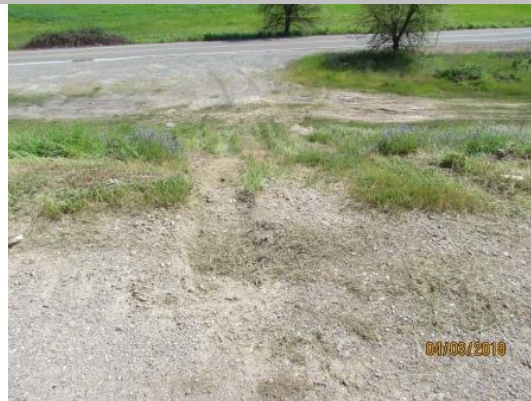
Photo 1 of 1 : SP\_2018\_RD1001\_38\_51\_20180411\_00095.jpg

View of continual vehicles driving up levee slope, should be monitored and maintained, Spring 2018.

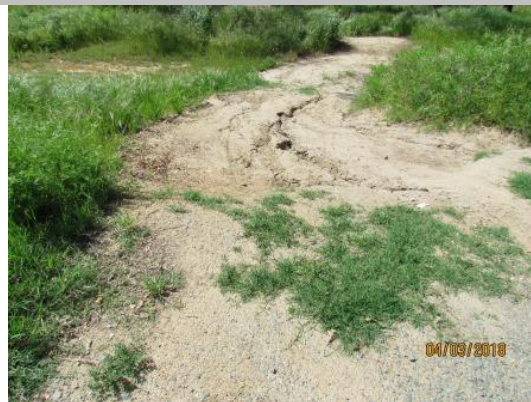
Photo 1 of 1 : SP\_2018\_RD1001\_38\_70\_20180411\_00096.jpg

View looking downstream waterside of the slope that is damage by vehicle traffic, Spring 2018.

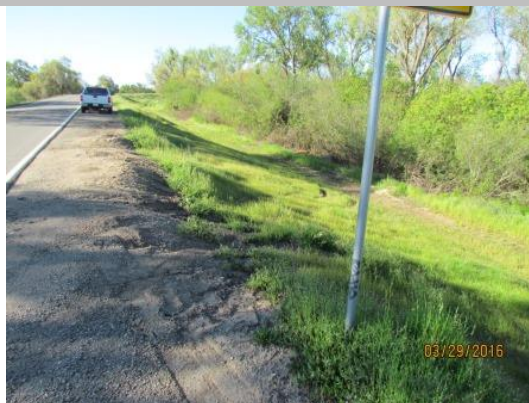
Photo 1 of 2 : SP\_2018\_RD1001\_38\_78\_20180302\_00059.jpg

Ruts on waterside slope due to vehicles. Spring 2016.

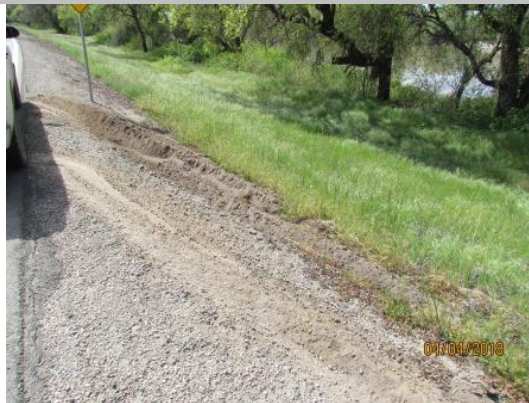
Photo 1 of 1 : SP\_2018\_RD1001\_38\_40\_20180411\_00097.jpg

View looking downstream waterside at deep tire ruts in levee slope, Spring 2018.

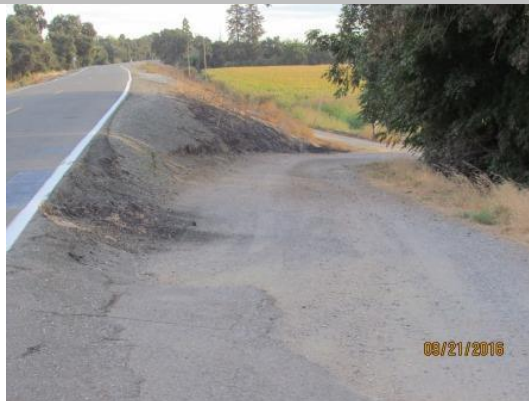
Photo 1 of 1 : SP\_2018\_RD1001\_38\_36\_20180302\_00026.jpg

View of vertical cut for ramp in the landside levee slope looking upstream. Fall 2016.

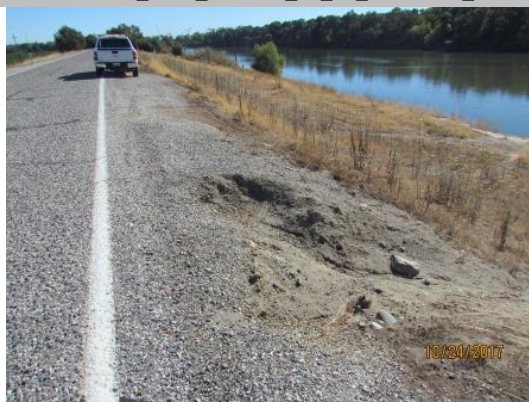
Photo 1 of 1 : SP\_2018\_RD1001\_38\_50\_20180302\_00038.jpg

View looking downstream waterside of damages cause by vehicles driving on the levee slope, Fall 2017.

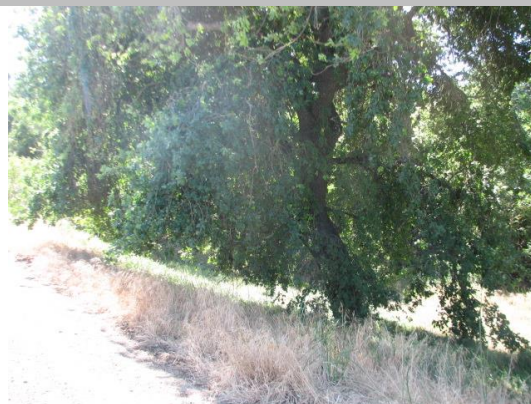
Photo 1 of 1 : SP\_2018\_RD1001\_38\_151\_20180302\_00063.jpg

Trees need to be trimmed up at least 5 feet. Spring 2013

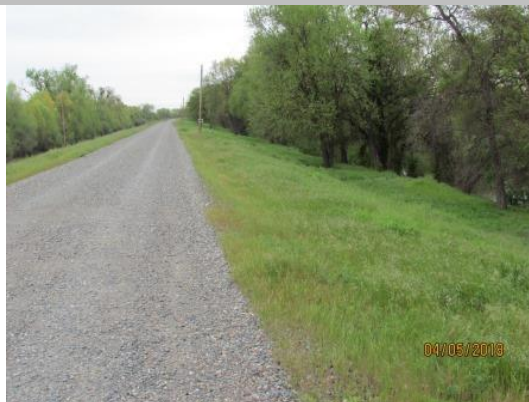
Photo 1 of 1 : SP\_2018\_RD1001\_39\_17\_20180411\_00026.jpg

View looking upstream waterside of the annual vegetation that needs to be maintained for better visual inspection, Spring 2018.

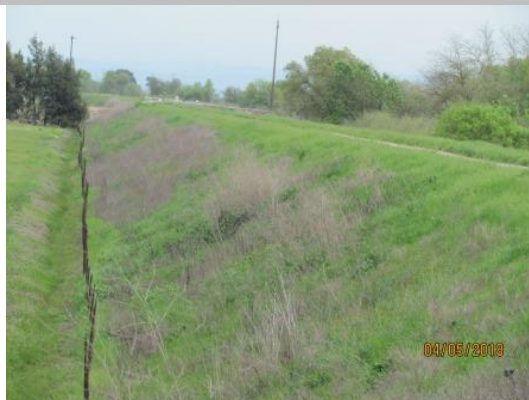
Photo 1 of 1 : SP\_2018\_RD1001\_40\_1\_20180411\_00041.jpg

View looking upstream landside of the annual vegetation that has gotten too tall and needs to be maintained for better visual inspection, Spring 2018.

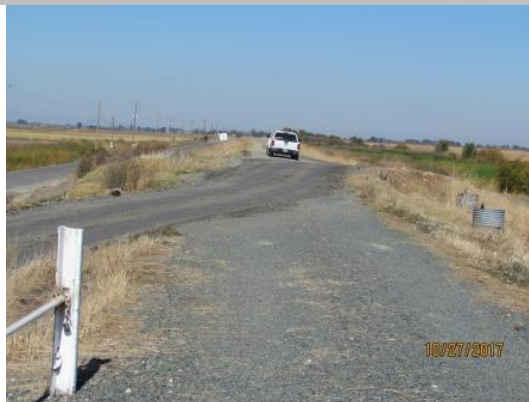
Photo 1 of 1 : SP\_2018\_RD1001\_40\_8\_20180302\_00004.jpg

View of crown where there is cross traffic looking upstream. Monitor this area and fix as needed, Fall 2017.

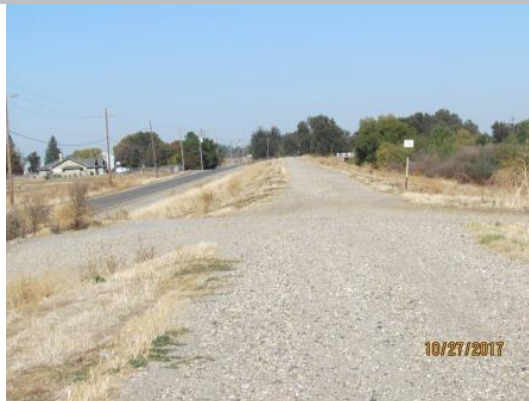
Photo 1 of 1 : SP\_2018\_RD1001\_40\_7\_20180302\_00003.jpg

View of crown where there is cross traffic looking upstream. Monitor this area and fix as needed, Fall 2017.

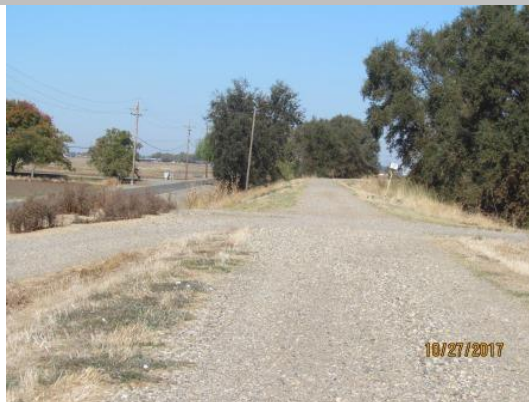
Photo 1 of 1 : SP\_2018\_RD1001\_40\_19\_20180302\_00009.jpg

View of crown where there is cross traffic looking upstream. Monitor this area and fix as needed, Fall 2017.

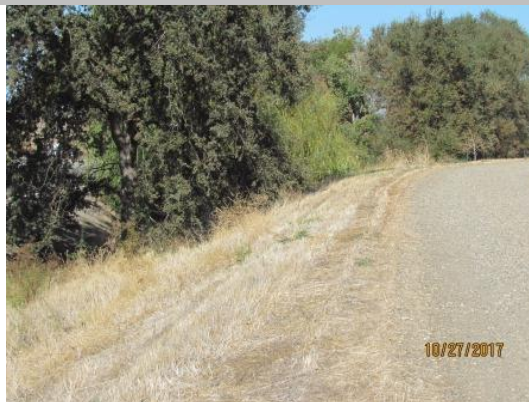
Photo 1 of 1 : SP\_2018\_RD1001\_40\_17\_20180302\_00006.jpg

View looking upstream landside at trees that need to be trimmed for access and visibility, Fall 2017.

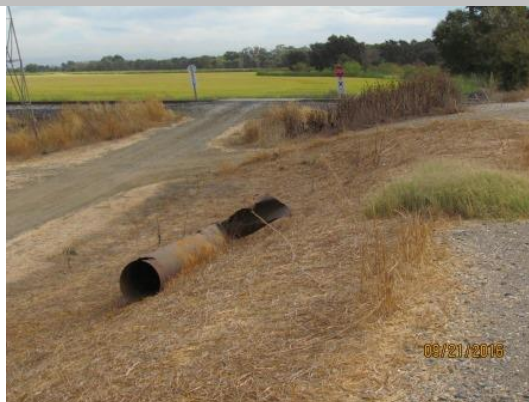
Photo 2 of 2 : SP\_2018\_RD1001\_40\_24\_20180302\_00013.jpg

View of an old piece of pipe lying on landside levee slope looking upstream. Fall 2016.
